**Development of Out-of-plane Strengthening
System by Passive Compression for
Masonry Walls**

JUNE 2014

DOCTOR OF ENGINEERING

YULIA HAYATI

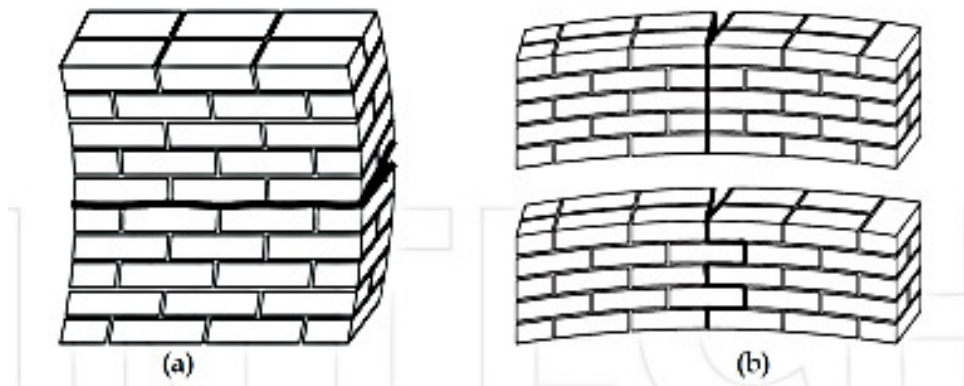
Figure 2.1 Flexural load failure (a) parallel to the horizontal joints and (b) perpendicular to the horizontal joints

The brick wall is recognized as material with brittle behavior and low resistance to seismic action especially out-of-plane loads. The out-of-plane failure behavior of masonry building has been investigated by some researchers. According to Zhimmermann and Strauss (2012), the flexural loading is a load case which is quite common. As shown in Figure 2.1, when wall is loaded by such as out-of-plane load to its surface then flexural stresses in the perpendicular and the parallel direction of the horizontal joints occur.

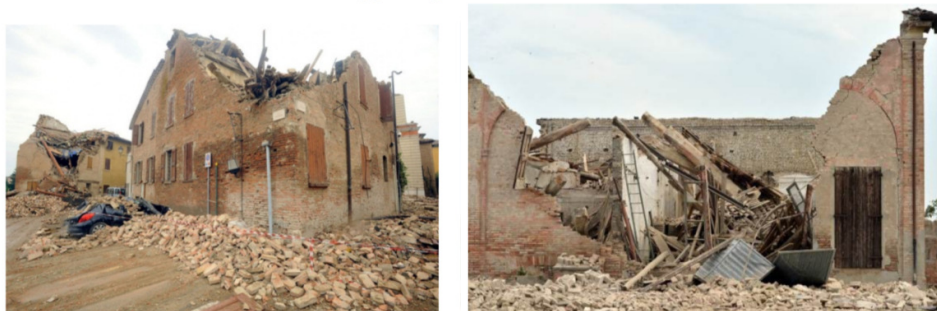
Photo 2.1 Out-of-plane failure of brick masonry buildings

Augenti et al. (2013) reported that in May 2012 an magnitude M_L 5.9 earthquake occurred in Emilia Romagna region of Italy. The earthquake caused severe damage to the masonry buildings without RC tie beams in the out-of-plane direction, as shown in Photo 2.1

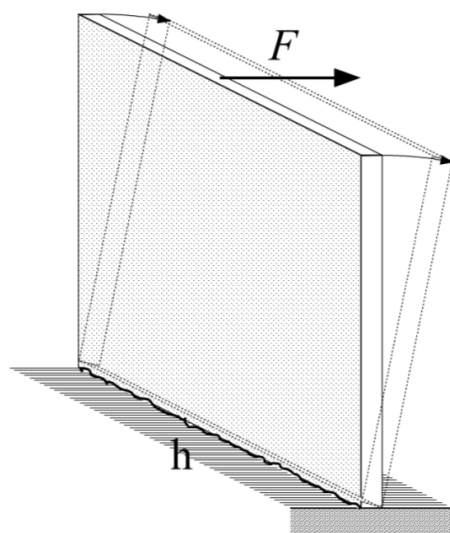
Figure 2.2 Overturning cause by out-of-plane load

Figure 2.2 shows that the ground motion is acting transverse to a cantilever or free-standing masonry walls, as report by Arya et al. (2013). The out-of-plane load acting on the mass of the wall tends to overturn it. This wall will collapse as show in Photo 2.2.

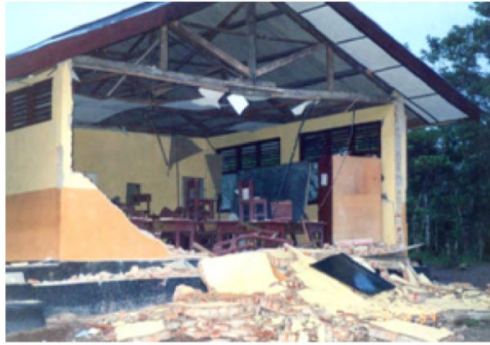
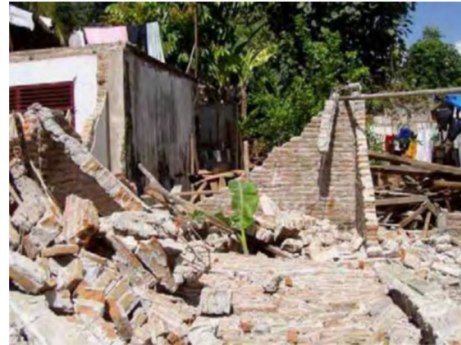
Photo 2.2 Out-of-plane failure of masonry walls

1994 Liwa Earthquake, Indonesia

2006 Central Java Earthquake, Indonesia

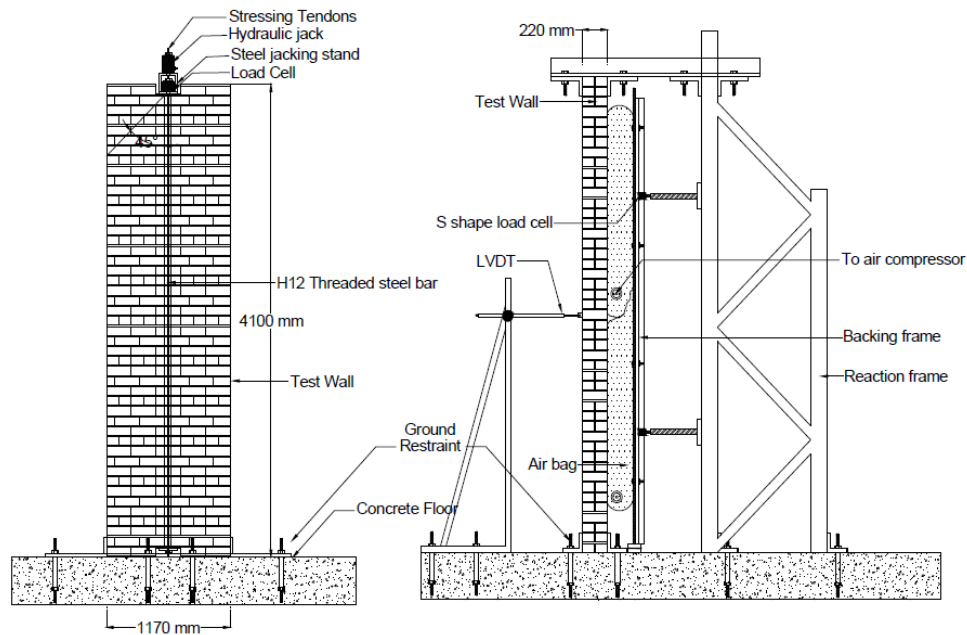
Figure 2.3 Test setup proposed by Ismail et. al. (2009)

Ismail et al. (2009), Griffith and Vaculik (2007) and Paulopereira et al. (2011) made a similar test set up for applying out-of-plane load to damaged masonry walls. They used full scale URM wall specimens, as shown in Figure 2.3. In order to have equal pressure and to allow a transmission of a distributed load to the masonry panel, those tests used airbags. All walls were simply supported at top and bottom.

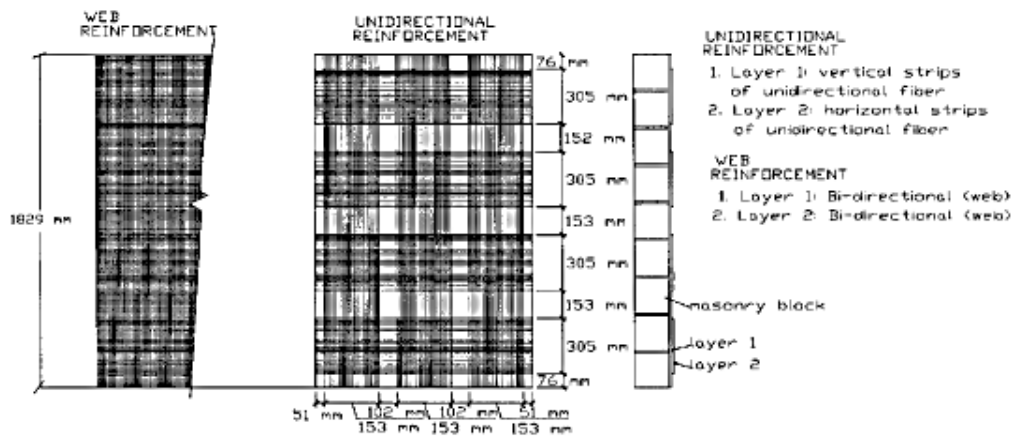
Figure 2.4 Using FRP overlay as external reinforcement techniques by Hamoush et al. (2001)

The surface treatment seems to incorporate external reinforcements in some techniques by Hamoush et al. (2001) and Bajpai et al (2003). They applied fiber reinforced polymer overlays and bars, respectively, to upgrade existing masonry walls. Figure 2.4 and 2.5 shows their techniques, respectively.

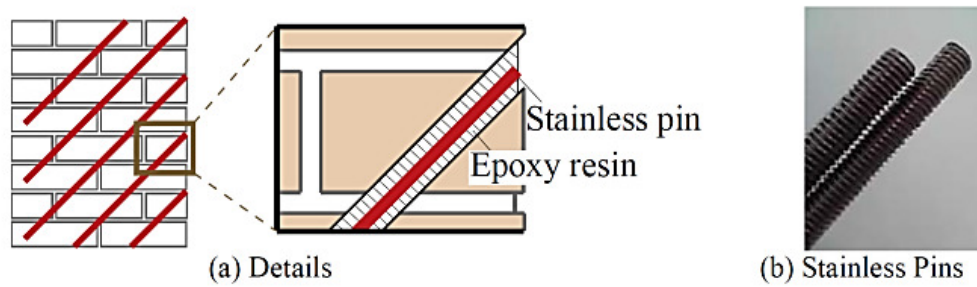
Figure 2.6 Method of inserting stainless pins by Takiyama et al. (2008)

On the other hand, the grout and epoxy injection and the confining by R/C tie columns are very conventional techniques for retrofit. As shown in Figure 2.6, Takiyama et al. (2008) proposed developed techniques by inserted stainless pins with epoxy resin in masonry walls to strengthen the out-of-plane performance, and F. Mosele et al (2006) presented new systems which incorporated ties into masonry walls, as shown in Figure 2.7.

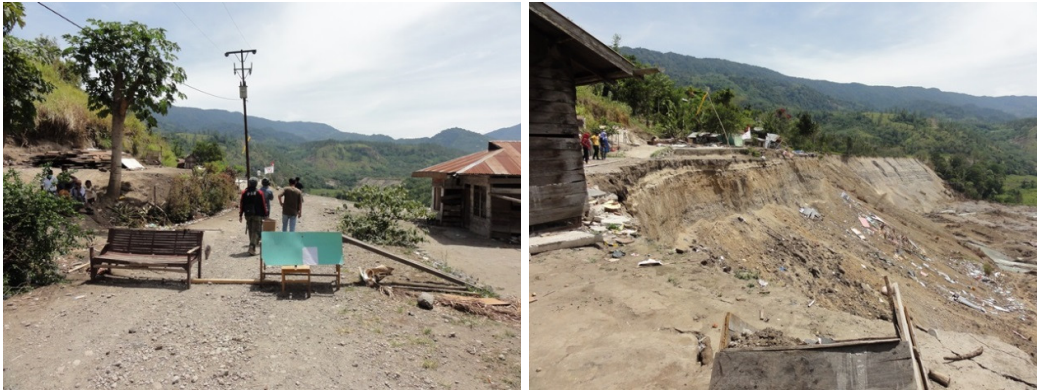
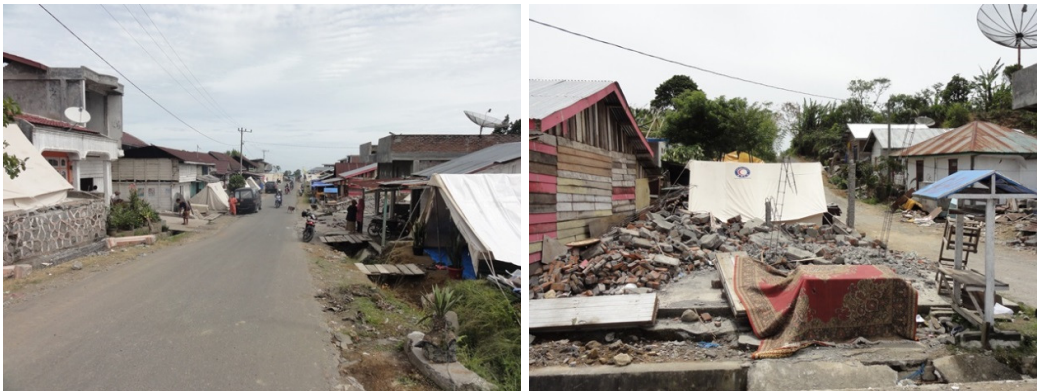
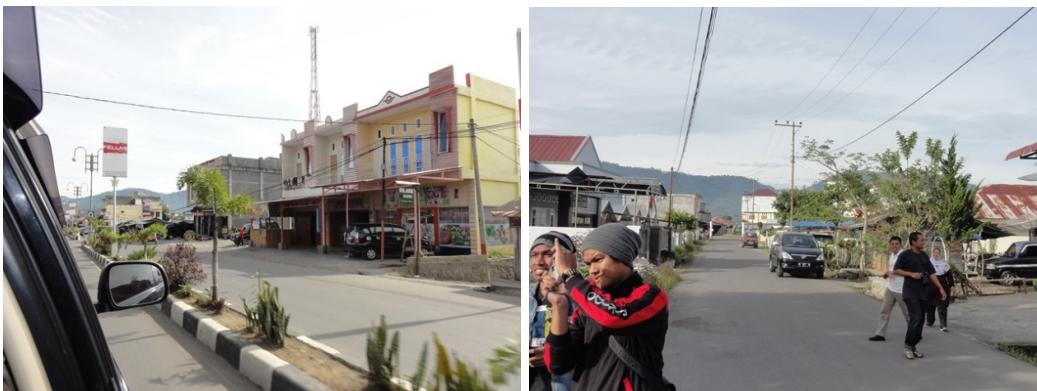
Photo 3.1 Investigated area

(a) Serempah on the epicenter

(b) Ratawali village at about 11 km from the epicenter

(c) Takengon

Based on reports by the United Nations Children's Fund (UNICEF) Indonesia (Unicef, 2013), the earthquake affected Aceh Tengah and Bener Meriah districts. Table 3.1 shows the summary of earthquake disasters in Aceh Tengah and Bener Meriah districts, respectively. Completely collapsed houses were observed at several villages close to the epicenter, while Takengon, the capital of Aceh Tengah district about 20 km southeast from the epicenter, did not suffer serious damage, as shown in Photo 3.1.

The first stage of investigation was a preliminary damage survey in Takengon and mountain areas close to Serempah village on the epicenter of earthquake to observe typical buildings/housings and their damage. Figure 3.2 shows the survey route map from Banda Aceh to the affected area. Photo 3.1 shows the condition around Takengon city and mountain areas close to the epicenter of earthquake.

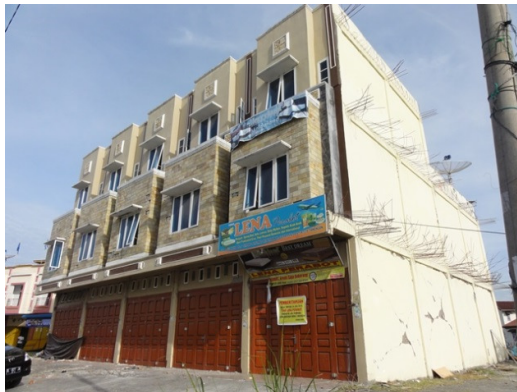
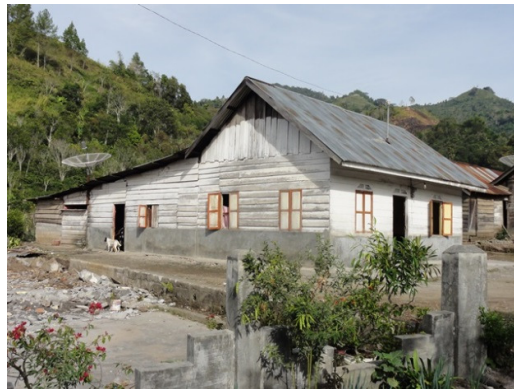
Photo 3.2 Typical structures at earthquake-damaged area

(a) Reinforced concrete

(d) Timber with masonry spandrel wall

Photo 3.2a shows an example of typical RC buildings whose major damage was observed to non-structural masonry walls as well as structural columns. Severe damage to non-structural walls prevented RC buildings from immediate occupancy, as shown in Photo 3.3. CM houses consist of brick walls with slender RC tie columns/beams, which are provided along the perimeters of masonry walls, and a wooden/aluminum roof truss with tiles/zinc plates or an RC roof slab, as shown in Photo 3.2b. This type of construction suffered moderate to heavy damage, such as: complete collapse, collapse

of confining elements, out-of-plane failure of walls, etc., as shown in Photo 3.4. Photo 3.2c and 3.2d show T and T+M houses, respectively. These constructions consist of wooden walls and a roof made of tiles/zinc plates, while T+M construction has brick spandrel walls under wooden walls. Damage to these systems were generally lighter, however some of them leaned due to ground settlement or damage to masonry spandrel walls, as shown in Photo 3.5.

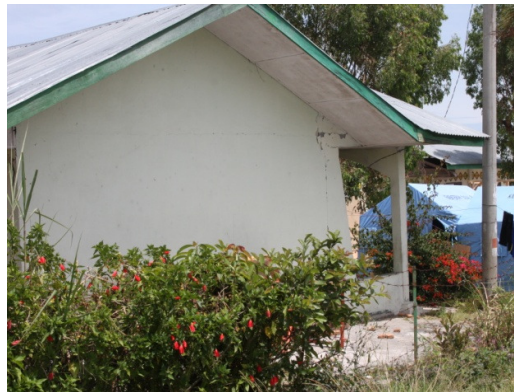
(b) Confined masonry

Building/housing structural systems can be roughly classified into four types: 1) Reinforced Concrete (RC), 2) Confined Masonry (CM), 3) Timber (T), and 4) Timber with Masonry spandrel wall (T+M), as shown in Photo 3.2. The last three types were typical structures at villages in the mountain range close to the epicenter.

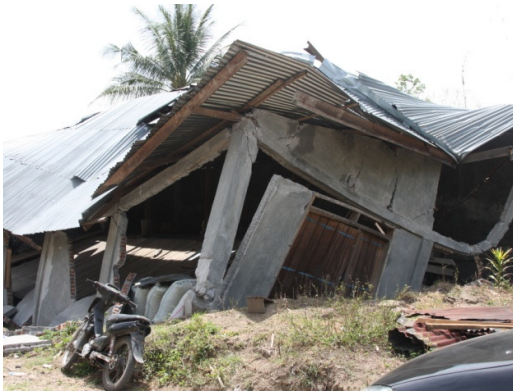
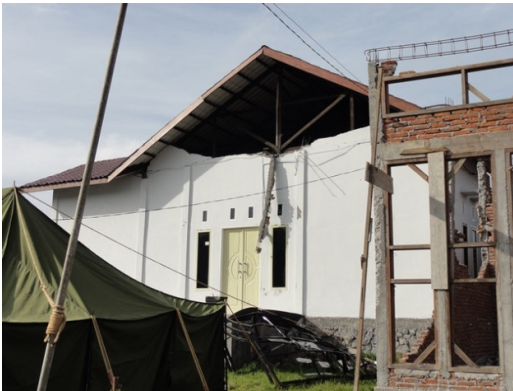
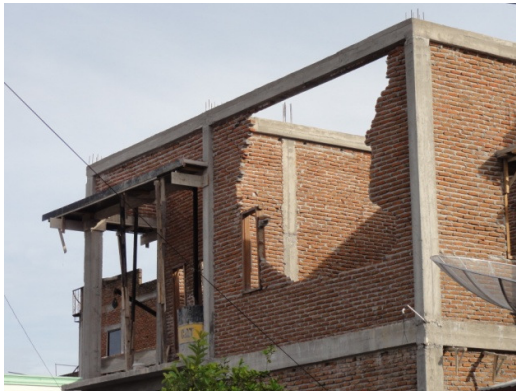
Photo 3.4 Typical damage to confined masonry

(a) Complete collapse

(b) Collapse of confining element

(c) Out-of-plane failure of gable wall

(d) Out-of-plane failure of wall

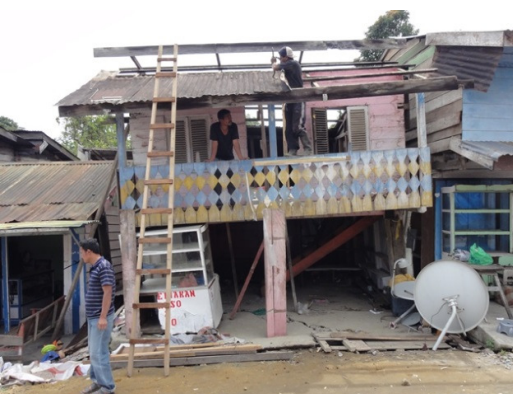
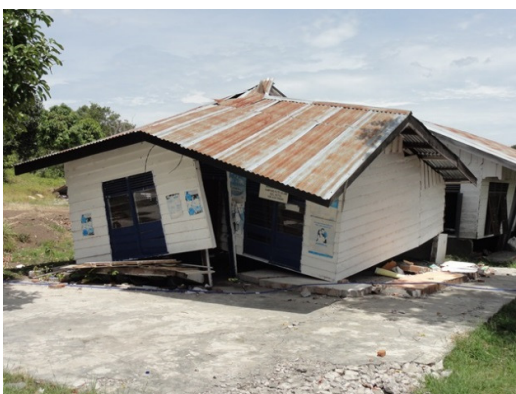
Photo 3.5 Damage to timber

(a) T house damaged due to ground settlement

(b) T+M house leaning with failure of masonry spandrel walls

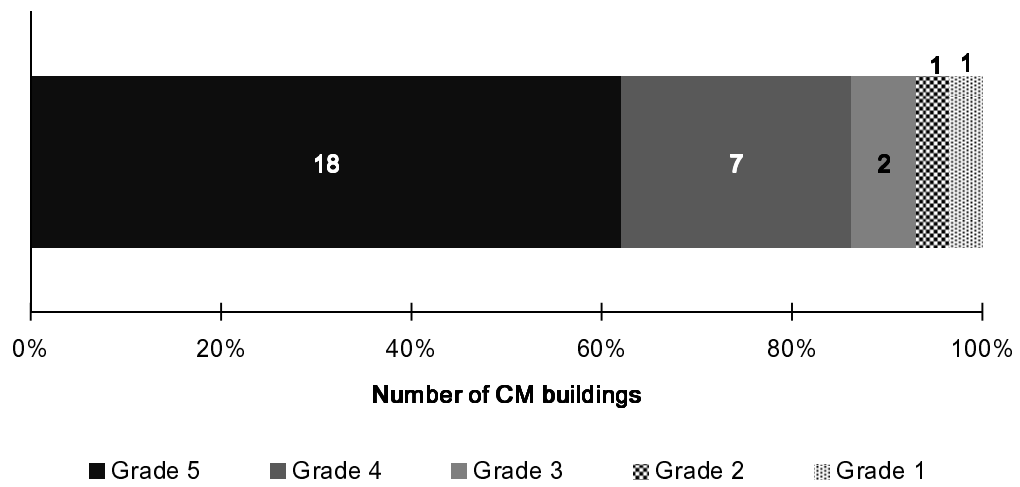
Figure 3.5 Distributions of damage grade for CM constructions

Damage to RC and CM structures was classified into five grades based on European Macroseismic Scale 1998 (EMS-98) (Grunthal. G, 1998). Table 3.2 summarizes the damage classification for masonry buildings by EMS-98 and Photo 3.6 gives samples of the damage grades for CM structures. Figure 3.5 shows the distributions of damage grade for RC and CM constructions. Only one sample of RC building was categorized into Grade 4 due to severe damage to columns, as shown in Photo 3.7, according to EMS-98 in which heavy structural/non-structural damage was defined as Grade 4. Total 29 CM structures suffered severe damage: Grades 5 and 4 for 62% and 24% of the total, respectively.

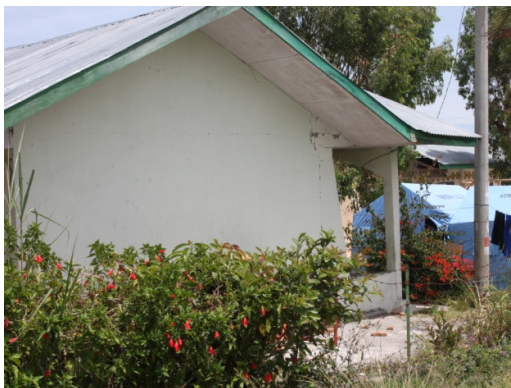
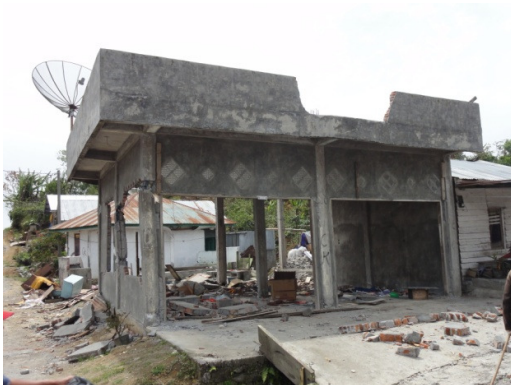
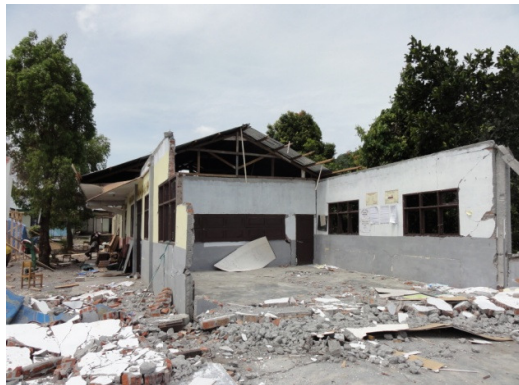
Photo 3.6 Examples of damage grades of CM structures

Grade 1

Grade 4

Grade 5

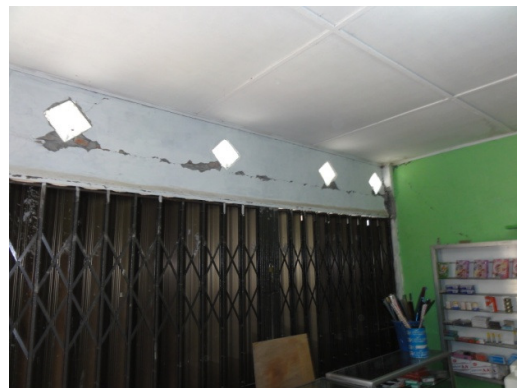
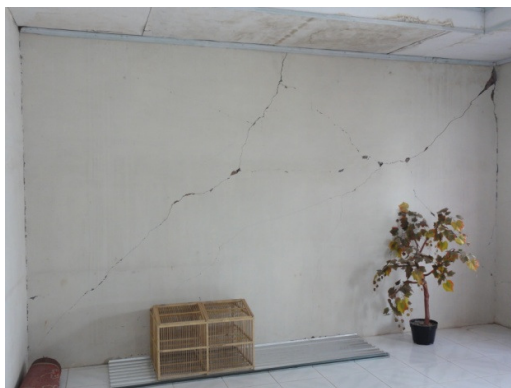
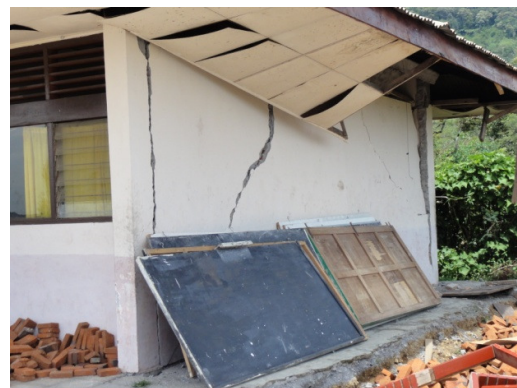
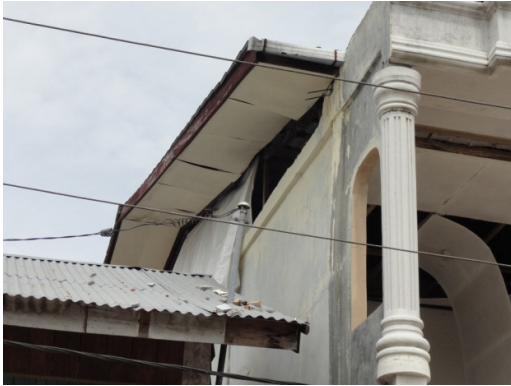
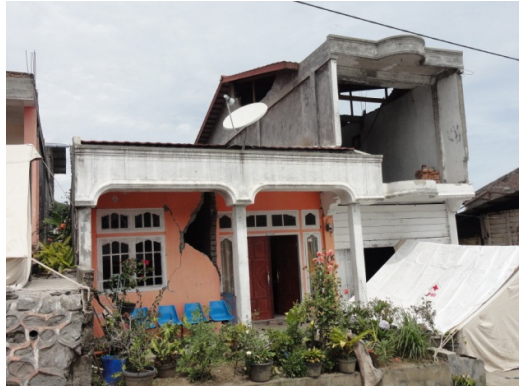
Grade 2

Grade 3

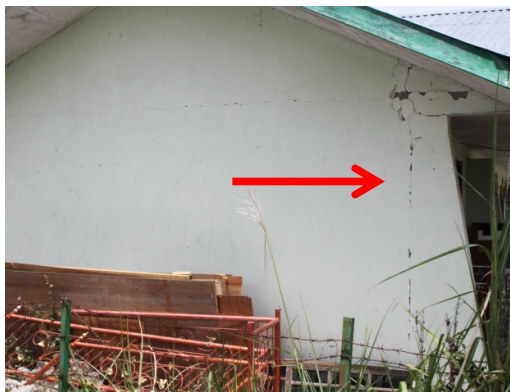
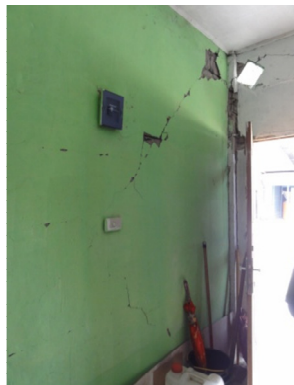
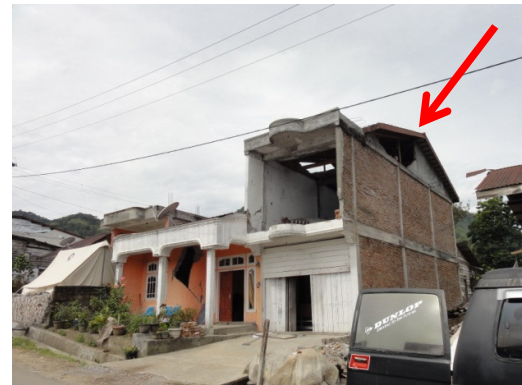
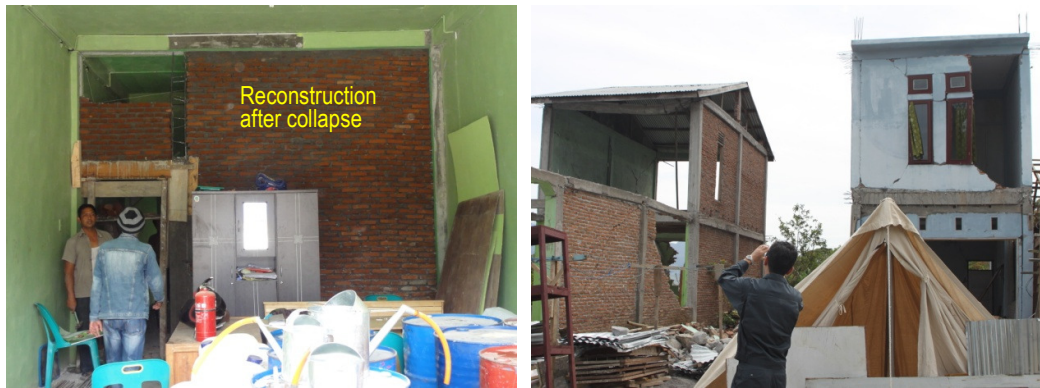
Photo 3.8 Examples of wall damage to CM structures

Separation between wall and column

Leaning of wall

Shear crack on wall

Out-of-plane failure of gable wall

Out-of-plane failure of wall

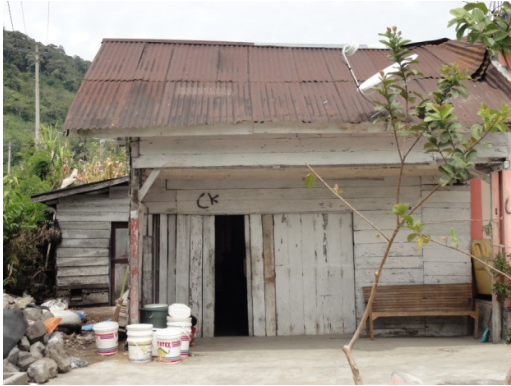
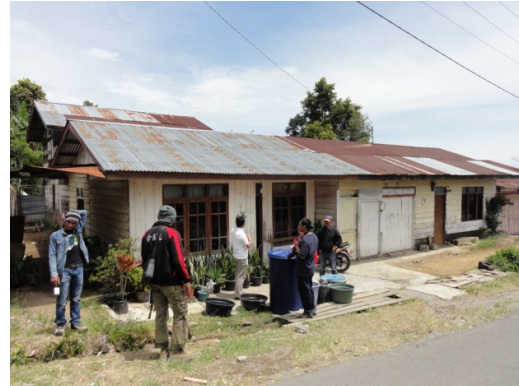
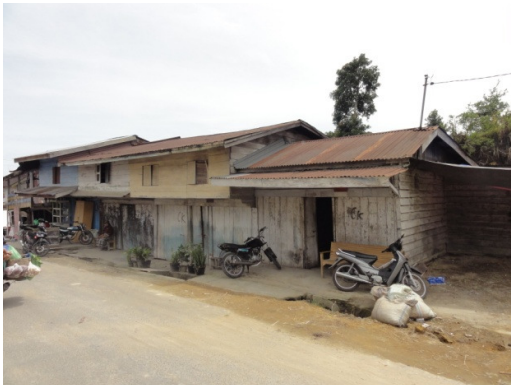
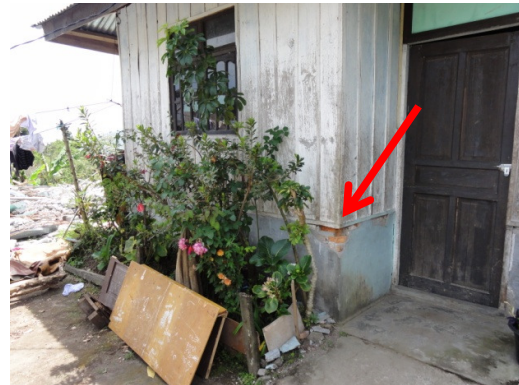
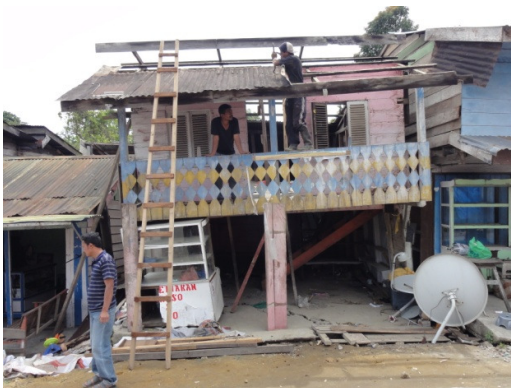
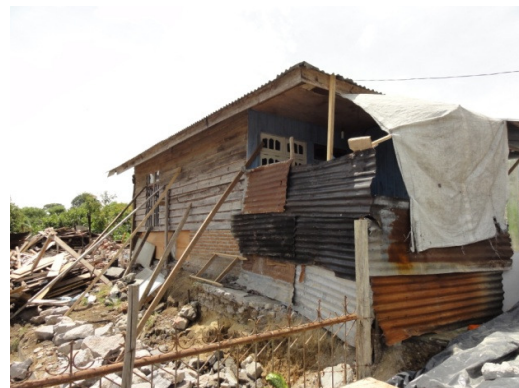
Photo 3.9 Examples of damage grades of T and T+M structures

Grade 1 for T

Grade 1 for T+M

Grade 2 for T

Grade 2 for T+M

Grade 3 for T

Grade 3 for T+M

On the other hand, damage grades for T and T+M constructions were classified into three grades based on the authors' visual observations to typical damage, as shown in Table 3.3. Damage grades for T and T+M constructions are exemplified in Photo 3.9, and their distributions are compared in Figure 3.7.

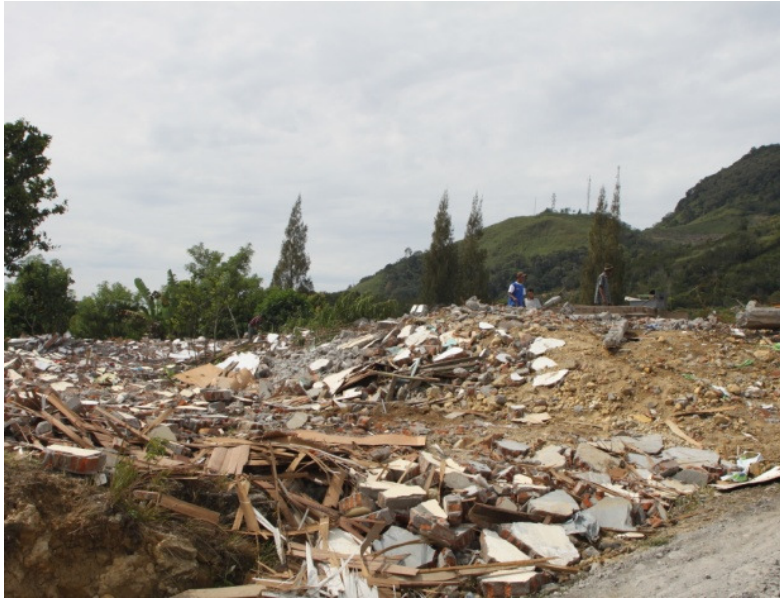
Photo 3.10 Collapsed elementary school building

One of the collapsed buildings which was located in Ratawali village, as shown in Photo 3.10, was focused to evaluate the seismic resistance of masonry walls in the out-of-plane direction. Based on the on-site inspection and interviews with the occupants, this single-story of simple masonry building was built in 1986 and used for an elementary school building. Some masonry rubbles were collected and transported to Syiah Kuala University to carry out laboratory tests to obtain the material properties. The rubbles were cut to the dimensions of 180 mm x 130 mm x 200 mm and 200 mm x 130 mm x 280 mm in width x thickness x height for compression and bending tests, respectively, as shown in Photo 3.11.

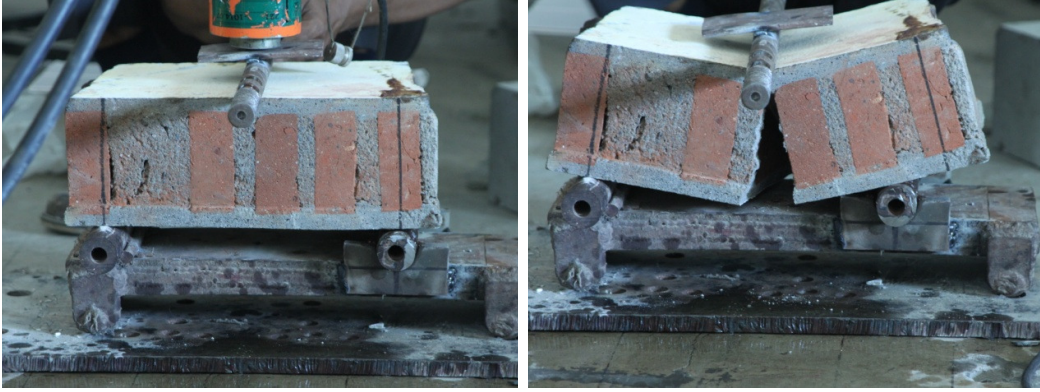
Photo 3.12 Bending test

As a result of the compression test, the averaged compressive strength in the longitudinal direction of prism specimens was 2.83 N/mm^2 . The tensile strength was obtained by three point load tests, as shown in Photo 3.12. The averaged value was 0.40 N/mm^2 according to Eq. 3.1.

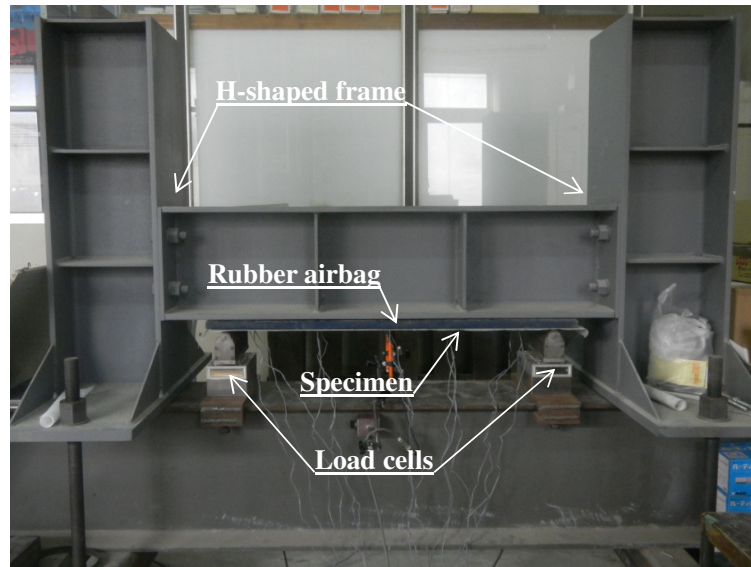
Photo 4.1 Front View of Out-of-Plane Loading System

Photo 4.1 shows an out-of-plane loading system for URM walls developed in this study. Design details of the system can be referred to Figure 4.1. A rubber bag jack (airbag), as shown in Photo 4.2, was adopted as a generator for uniform distributed loads normal to wall surfaces. Internal pressure in the airbag was generated by a widely used air compressor. The detailed information of rubber airbag is shown in Table 4.1. The airbag was placed between the reaction frame, which consisted of H-shaped steel and was anchored on a reaction floor, and prospective specimens, as shown in Photo 4.1 and Figure 4.1. Specimens were inserted below the airbag and simply supported in the system. Applied loads to specimens which resulted from the airbag were measured by load cells implemented under the roller supports.

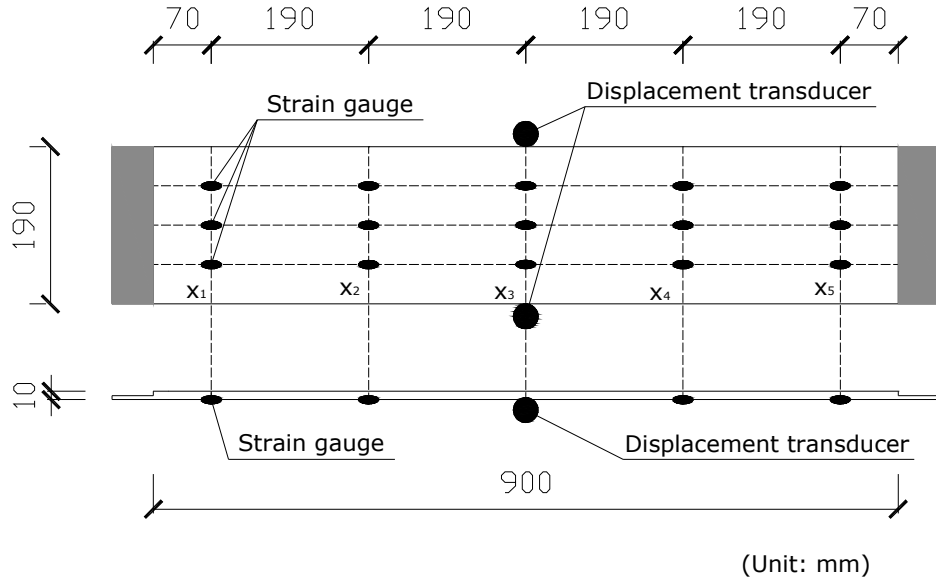
Figure 4.2 Measurements location on/beside the elastic specimen.

was verified through comparing experimental results with theoretical calculations. Table 4.2 shows the material properties of aluminum. Figure 4.2 illustrates locations of strain gauges/displacement transducers installed on the bottom surface/side faces of the specimen. In particular, output of each strain gauge means an extreme fiber strain on the tension side when loads were applied by the airbag.

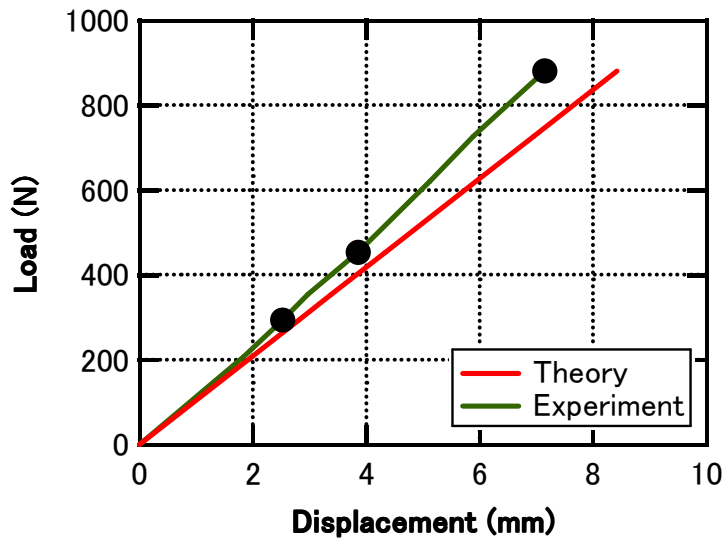
Figure 4.3a shows the relationship between applied load and vertical deformation at the middle span, where the experimental deformation is the averaged value of outputs from two transducers shown in Figure 4.2. Figure 4.3b shows a transition of the distributions of experimental strains, which represent the moment distributions, along the plate length under several loads indicated in Figure 4.3a. However, the experimental strain at each location means the averaged value of three measurements along the width of specimen, as shown in Figure 4.2. It was found that symmetric distributions were observed throughout the test. Moreover, in these figures, theoretical calculations are compared to the experimental results. Good agreements were observed between the experimental and theoretical values, which mean that the proposed out-of-plane loading system successfully subjected the specimen to uniform distributed loads.

(a) Comparison of load-deformation relationships

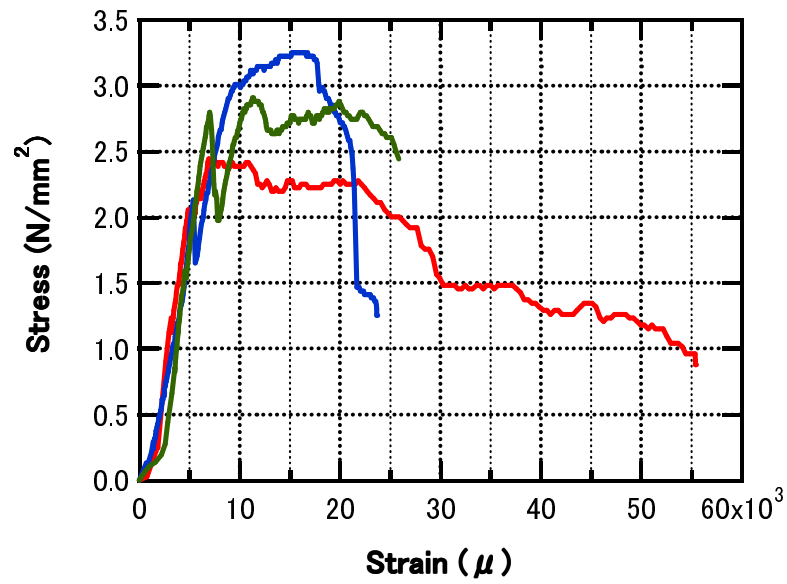
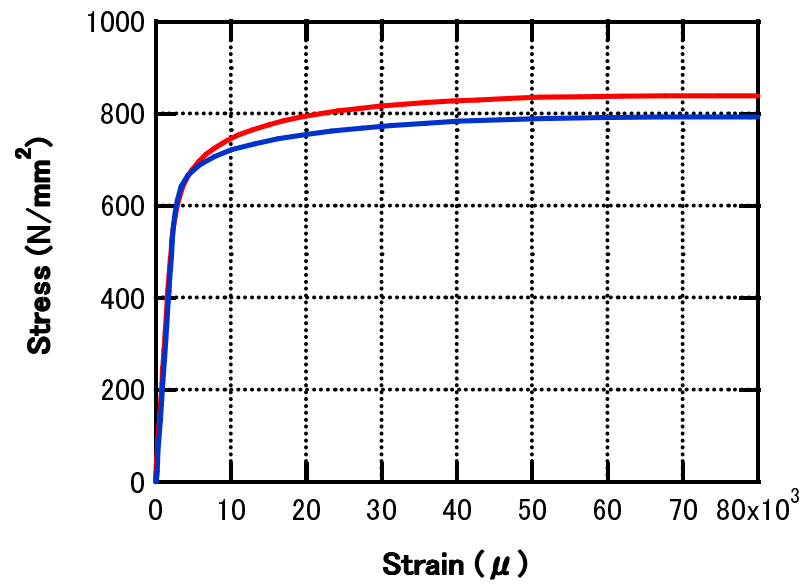
stress-strain relationships from tensile tests of steel rods are shown in Figure 5.2(b).

a) Compression test results of prism specimens of brick walls

b) Tensile test results of rods

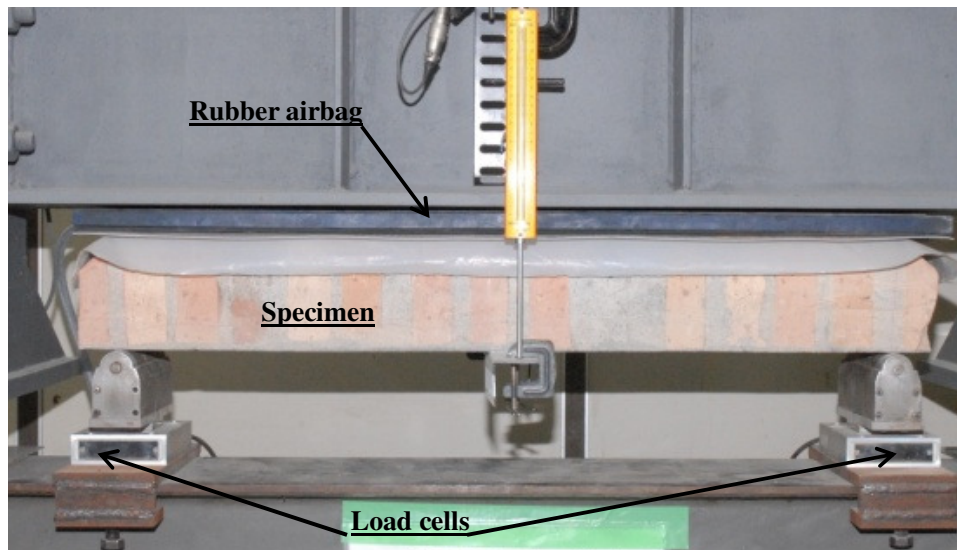
Photo 5.4 Front view of out-of-plane loading system

rods and resultant compression acted on the wall cross-sections. Initiated cracks were optically observed to identify the failure mechanisms.

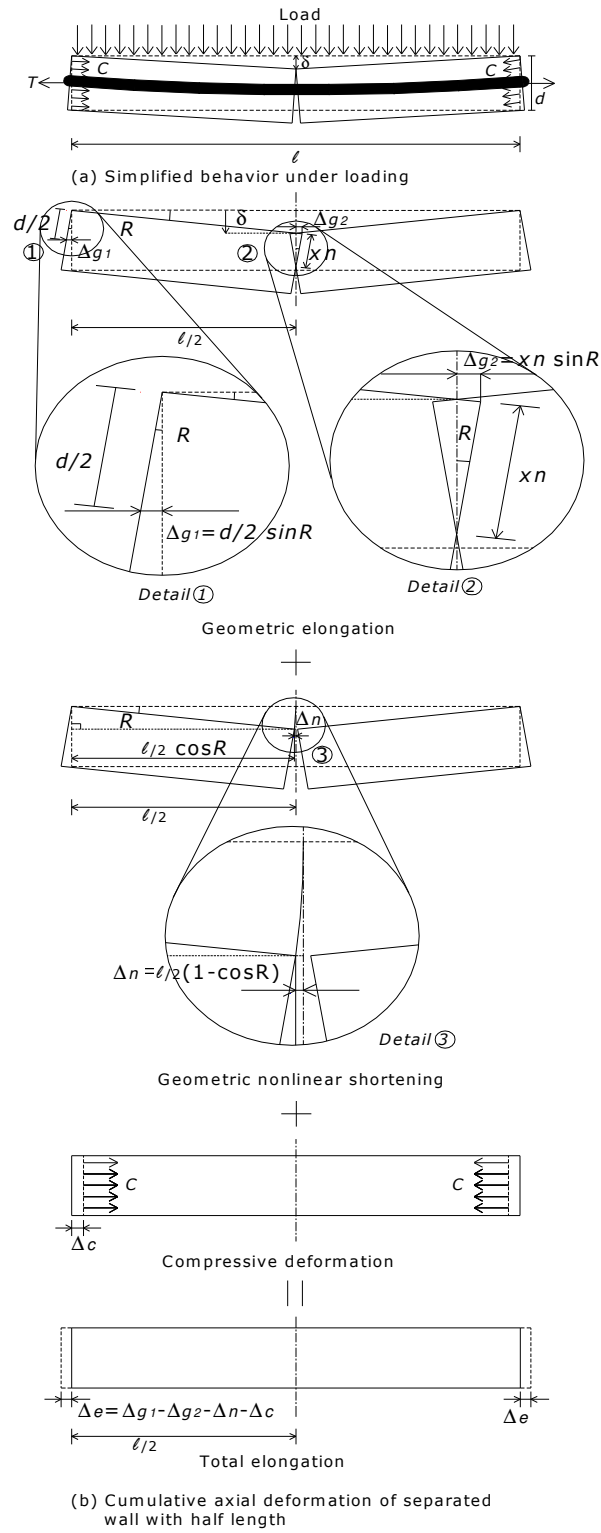
Figure 6.1 Analytical model for performance evaluation (symmetric model)

rotation of wall, Δ_g is caused by a rigid body rotation of $R (= \frac{\delta}{l/2})$, where δ : vertical deformation at the middle span, l : span length of wall). In the equation, however, shortenings of wall due to the geometric nonlinearity, Δ_n and the compressive deformation, Δ_c are considered. Consequently, an axial strain of restraint rods, ε_s is given by Eq. 6.3, and hence a restraining tension of T is obtained by Eq. 5.4. Conversely, a passive compression of C is applied to the wall as a reaction of T . A compressive deformation of wall, Δ_c , is calculated by Eq. 6.4.

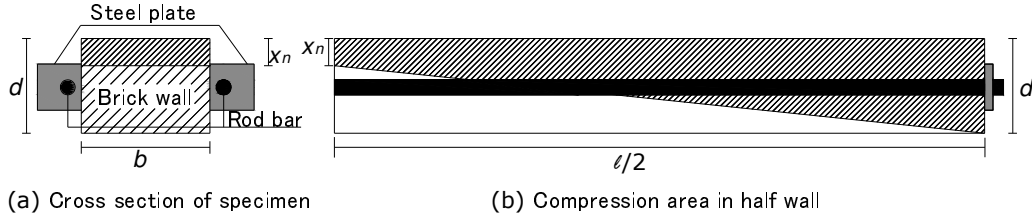
Figure 6.3 Assumption of compression area of wall

where, ε_m : strain of masonry, E_m : Young's modulus of wall, a_m : averaged cross-sectional area of wall which defined by $b \cdot \frac{x_n + d}{2}$ based on an assumption of compression area as described in Figure 6.3. This assumption briefly represented a reduction of compression area at the crack, however, the interpolated reductions between the crack and wall ends had not been experimentally verified in this study.

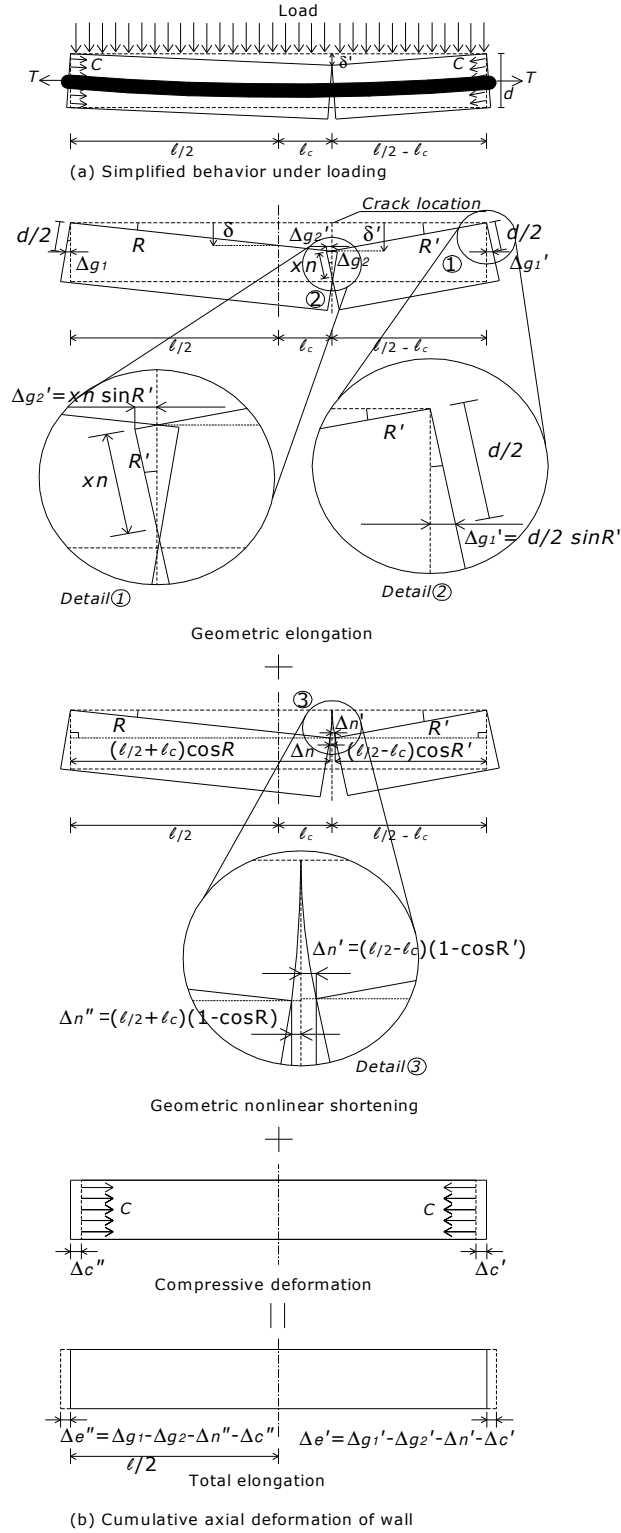
Figure 6.4 Analytical model for performance evaluation (asymmetric model considering crack location)

where $\square \delta'$: vertical deformation at the crack location, l_c : length from the middle span to crack location, Δ_c' , Δ_c'' : compressive deformation of shorter and longer walls, however, $\Delta_c' + \Delta_c'' = 2\Delta_c$.

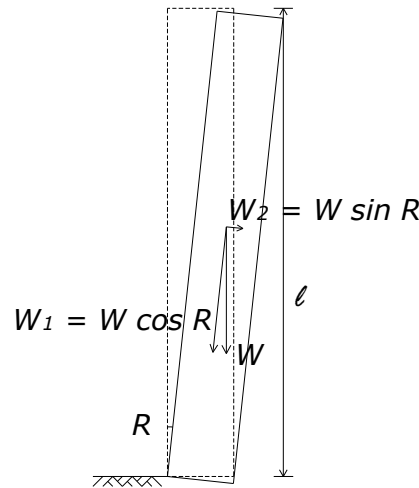
Figure 6.10 Effects of wall weight on out-of-plane performance

Figure 6.10 shows effects of the weight of wall itself on the out-of-plane performance, where W : typical weight of wall (250 kg/m^2 in the case of wall depth of d and 450 kg/m^2 for wall depth of $2d$) and $R = \frac{\delta}{l}$.

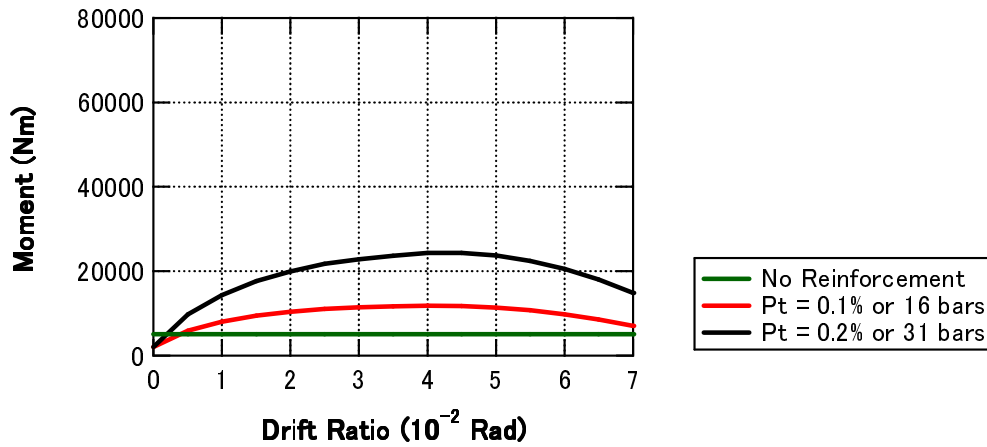
Figure 6.12 Moment capacity at the bottom for $1d$ depth wall

Figure 6.12 shows the relationship of moment capacity of wall and drift ratio at several P_t ratios and wall depth of d . Under these conditions, the calculation cannot be completed in the case s of P_t of 0.3% to 0.5%. This was due to greater x_n than half of wall depth. Figure 3 shows the relationship of moment capacity of wall and drift ratio with different P_t ratios and wall depth of $2d$. In this case, the calculation cannot be completed for P_t of 0.5% because of the same reason. Both of these figures show that the proposed strengthening method can be applied to typical masonry walls and generate much higher strengths than un-strengthened wall.

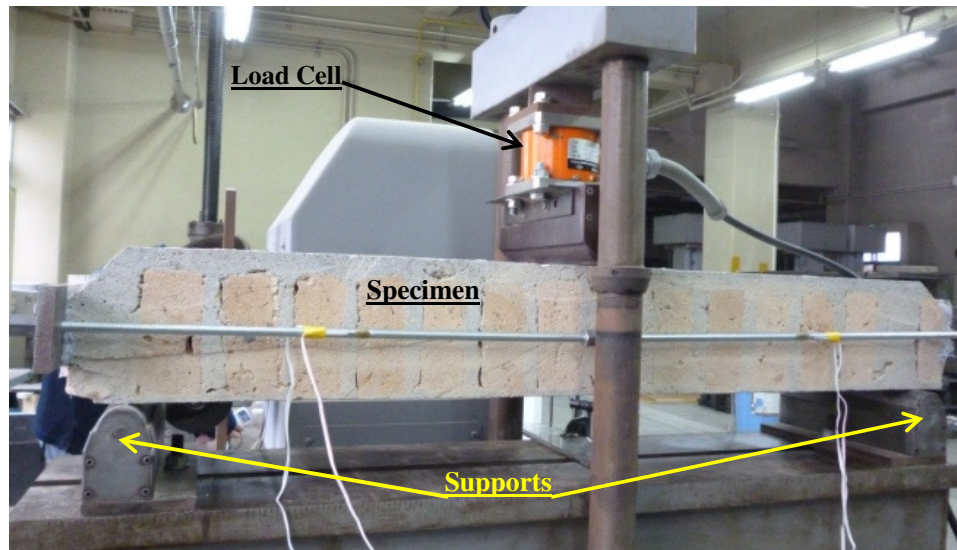
Photo A.1 Front view of out-of-plane loading system for three-point bending test

Photo A.1 shows a typical loading system for three-point bending tests on SP and SPI specimens. Details of the systems can be referred to Figure A.1. Set-up of measurements for loading tests can be seen in Figure A.2. Vertical deformations were measured at the middle span of the specimens. The figure also shows locations of strain gauges on the steel rods of the strengthened specimens, which were installed to measure tension of strengthening rods and compression acted on the wall cross-sections.

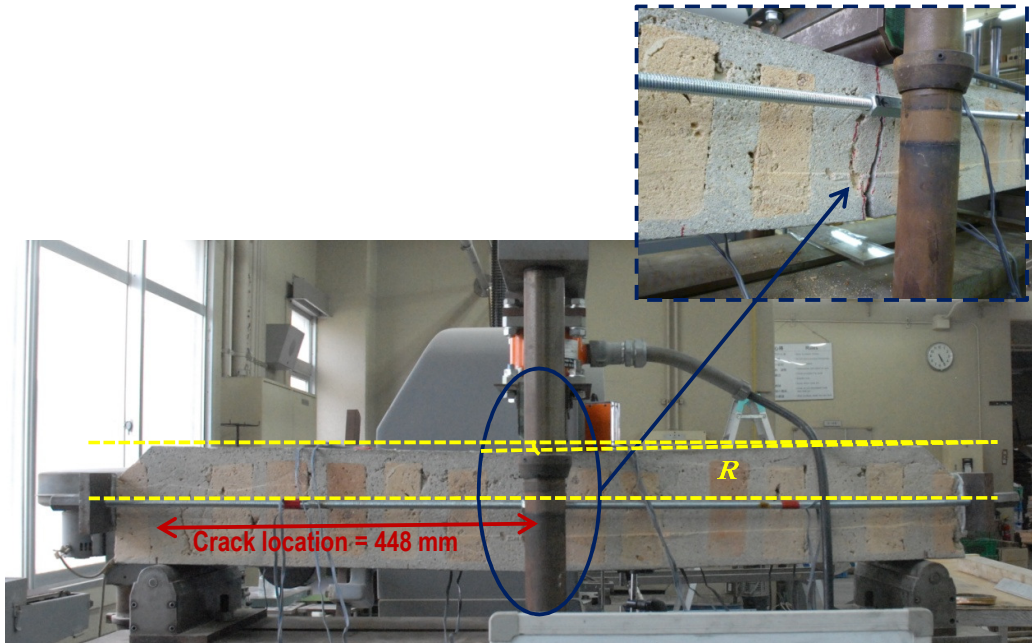
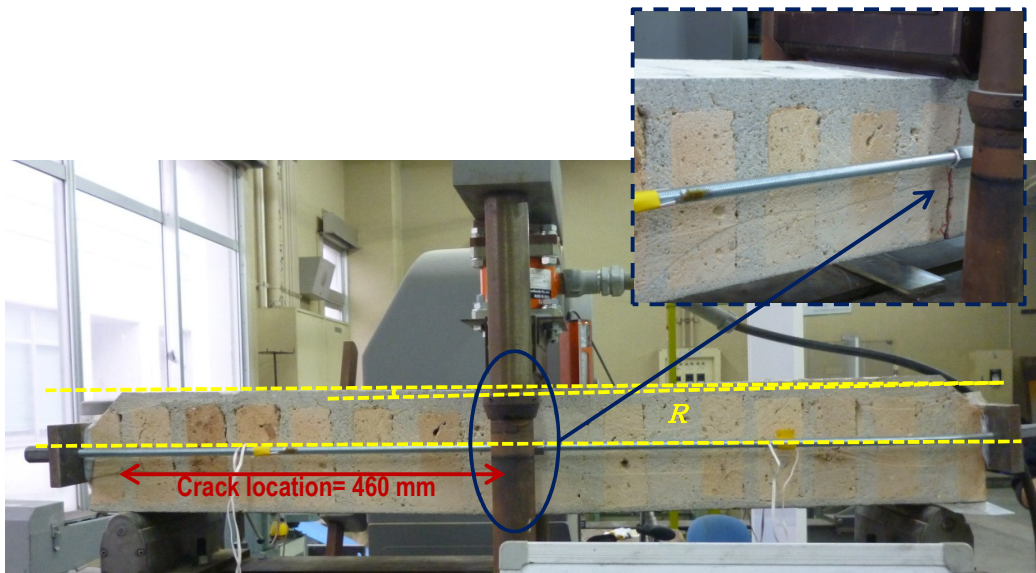
Photo A.2 Damage to specimens after/during loading

(a) SP at 2.1% drift ratio

(b) SPI at 2.0% drift ratio

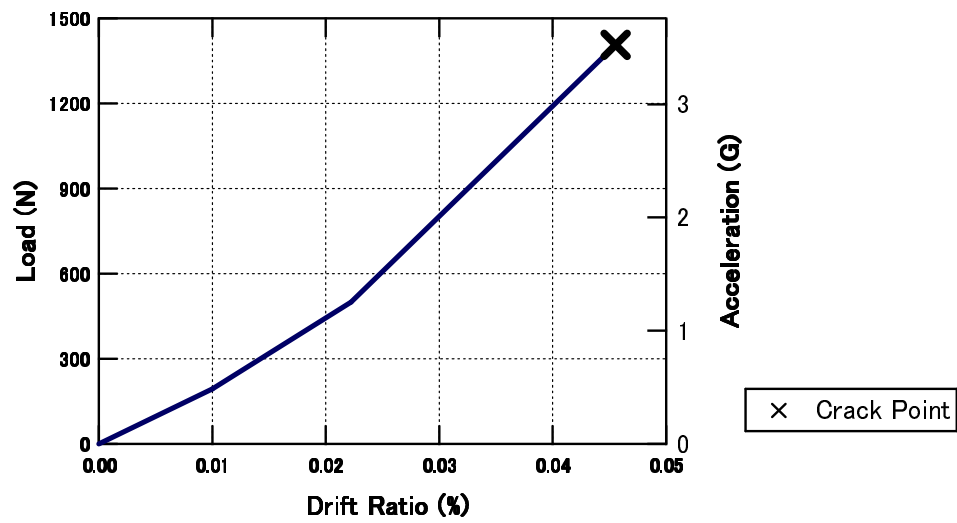
Figure B.1 Loads - Drift relationship of unstrengthen brick masonry specimen

As a result, it was found that the specimen failed under an acceleration of 3.5 G. Although the height of specimen was 900 mm due to the limitation of transportation, as shown in Photo 5.2, the actual height of infill walls was 2750 mm. This means that the actual walls attain the maximum moment at the middle span and fail under an acceleration of 1.1 G (= 3.5G x 900 mm / 2750 mm), however, which was estimated under an assumption that walls are simply supported at both ends. The out-of-plane resistance of infill should be considered to accurately evaluate the seismic performance of the earthquake-damaged buildings considering infill effects nevertheless it was not considered in the previous investigation (Swe, Maidiawati and Sanada, 2011).
